USAAVSCOM TR 89-D-21

**OPERATIONAL EFFECTS ON CRASHWORTHY  
SEAT ATTENUATORS**

**Marvin Kent Richards**

**Final Report for Period September 1987 - November 1989**

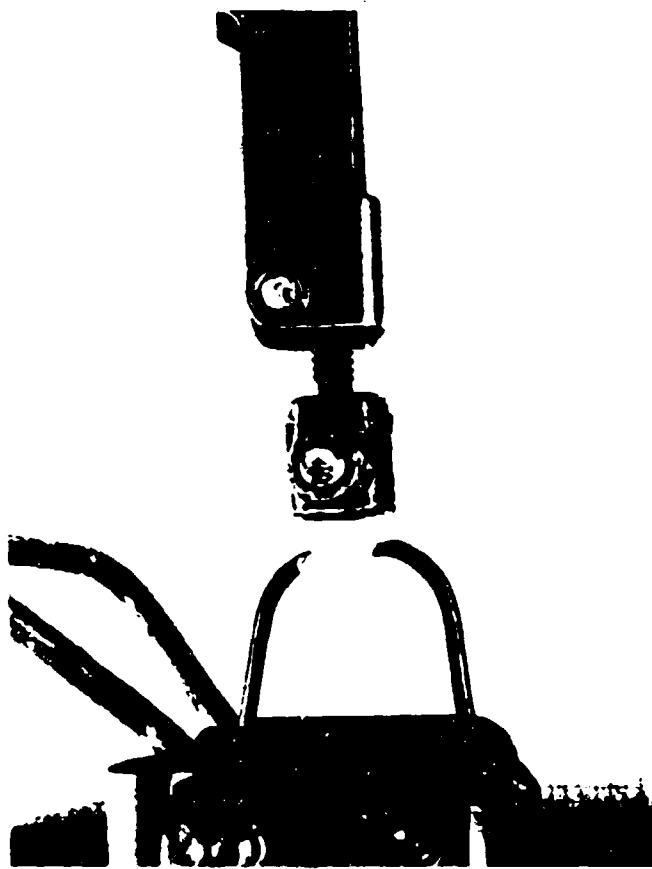
Two fielded energy absorbers from the same troop seat failed. Figure 9a shows the load-versus-displacement plot for one which failed at 1174 lb. The other energy absorber that failed (plot not shown) broke at 1087 lb. The two energy absorbers broke at the same location where the wire is suspended, as shown in Figure 10.

**FIGURE 10. TYPICAL STATIC TEST FAILURE - TROOP SEAT, FIELDIED ENERGY ABSORBER.**

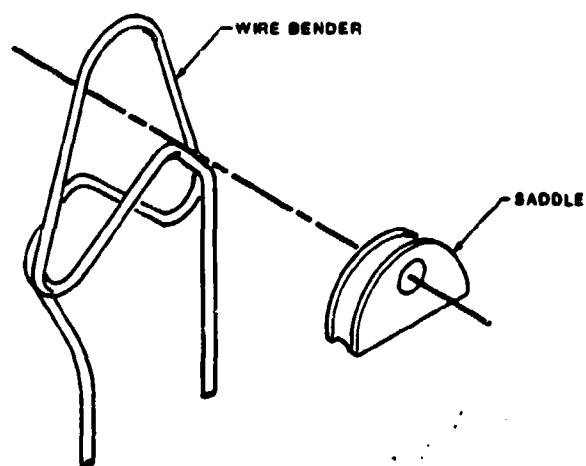
After the static testing was completed it was learned that new aircraft have a load-distributing saddle installed at the wire suspension point as shown in Figure 11. This modification was made to preclude wire failures at this location. Since the observed static test failures were at the suspension point, it was decided to test half of the remaining energy absorbers with the saddle installed to determine if this solution would alleviate dynamic failures.

**FIGURE 11. LOAD DISTRIBUTING SADDLE - TROOP SEAT DYNAMIC TESTING.**

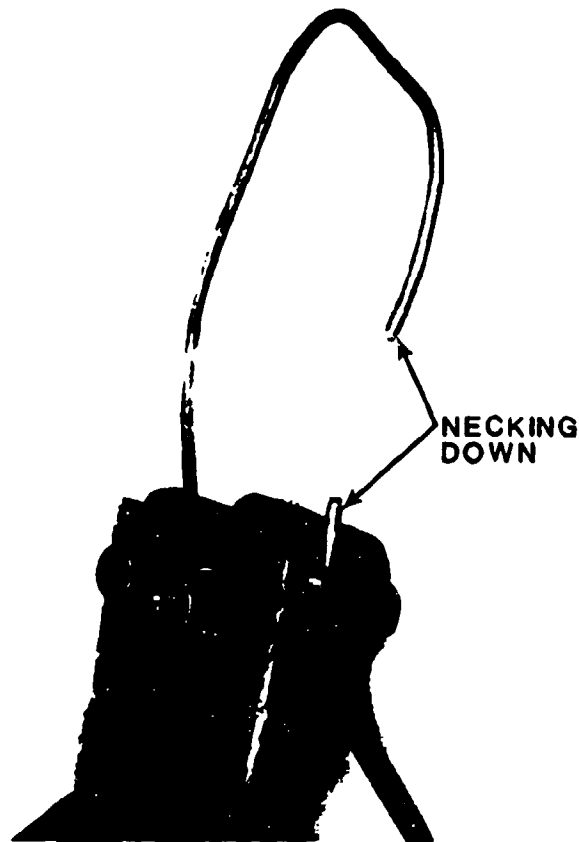
Figure 15 shows an example of a wire fracture. Breakage points of all failures were in the area where the wire wraps around the rollers. The wires experienced necking-down in the area of the fracture.

All dynamic failures occurred where the wire wraps around the rollers, indicating that the load distributing saddles were not a factor (11 broke with the saddle, 12 without). None of the new energy absorbers failed. The average load of new energy absorbers were only slightly higher (2.6 percent) than the fielded energy absorbers that did not fail. The energy absorbers consistently stroked approximately 280 lb under the desired nominal load of 1300 lb, with the exception of aircraft 78-22971 (seats 4a and 9b), which stroked at an average load of 1302 and 757 lb, respectively.

**FIGURE 15. TYPICAL WIRE FRACTURE DURING DYNAMIC TESTING -  
TROOP SEAT, FIELDIED ENERGY ABSORBER.**

Metallurgical inspection of the failed energy absorbers determined that all wire fractures were due to overstress. Table 8 compares the measured average peak load of the failed and successful energy absorbers for the three sources: T/N 720, T/N 971 and new (depot).

Since the peak load of the failed attenuators is approximately the same as the successful attenuators, it is concluded that the overstress was not caused by overload. The calculated direct tensile failure load of the attenuator is over 4000 lb, well above the loads experienced during these tests. This indicates that the overstress must be caused by some other mechanism such as a reduction in cross-sectional area, a reduction in the strength of the material, high localized bending stresses, or a combination of these factors.

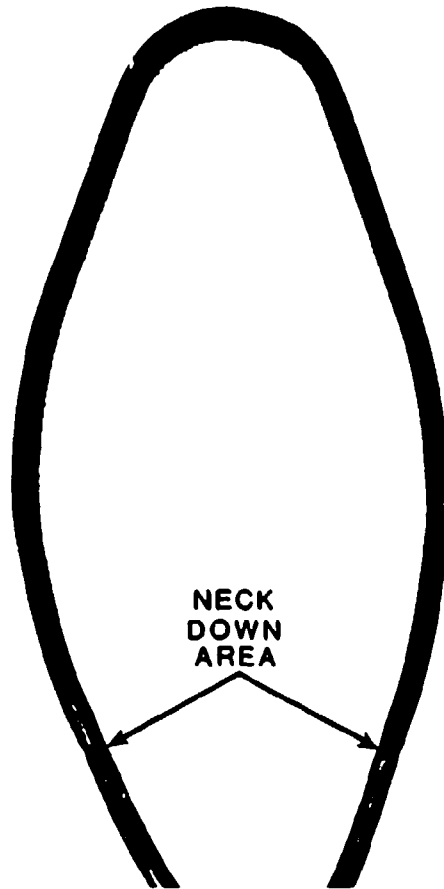
Two phenomena were noted upon posttest inspection of wires. The dynamically failed wires showed necking-down (severe deformation) of the wire diameter at the fracture point (see Figure 15). It was originally believed that the necking-down was only a result of the ductility in the wire and occurred as the wire was loaded to failure. However, inspection of wires that did not fail revealed some of these also had areas of necking-down as shown in Figure 16. Therefore, it appears that the initiation of the necking-down phenomenon occurred previous to, rather than during, the dynamic testing. The location of the neck-down area was measured and found to be approximately at the midpoint of the preformed minimum bend radius (0.19 in.) as shown in Figure 17. All of the dynamically failed wires broke in this area. The second phenomenon observed was localized flat spotting of wires due to contact with the rollers. This wear resulted at points of suspension due

**FIGURE 16. TROOP SEAT WIRE NECKING-DOWN.**

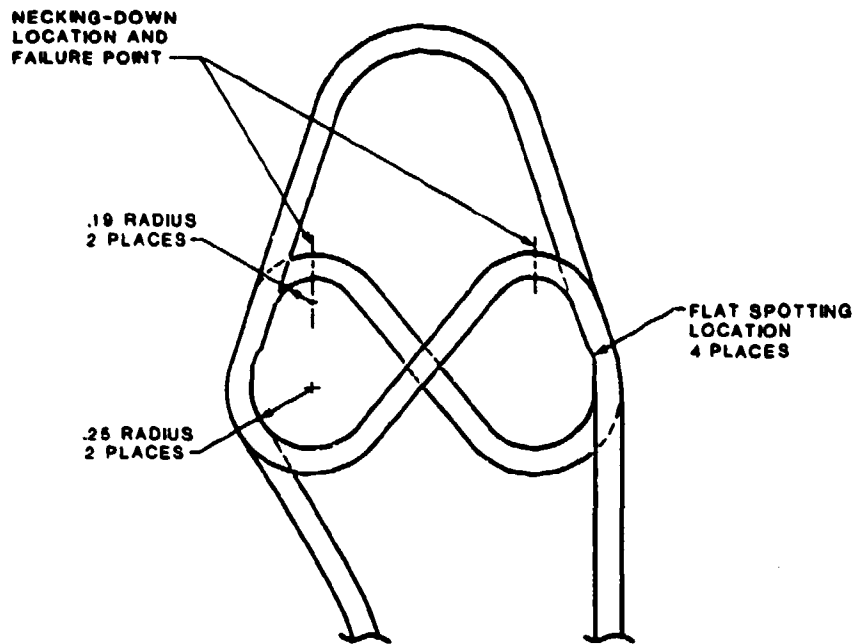
to the normal movement of seats (occupied and unoccupied) in the aircraft while subjected to vibratory flight loads. This localized wear appeared to be more severe in the -971 wires. Measurements made in the areas of localized wear revealed diameter reductions as much as 0.0025 in. when compared to unworn areas. None of the wires failed in the worn area.

A loss of cadmium plating (used as a dry lubricant) on almost all of the fielded wires was also observed along with varying degrees of light corrosion and debris in the wire-roller area. The roller mounting bolts also showed evidence of corrosion which served to increase friction and make the rollers more resistant to turning.

**FIGURE 17. PREFORMED WIRE LOCATION OF DYNAMIC FAILURES AND LOCALIZED WEAR.**
